e-mosty

ISSUE 01 / MARCH 2017

Queensferry Crossing. Forth Road and Railway Bridges.

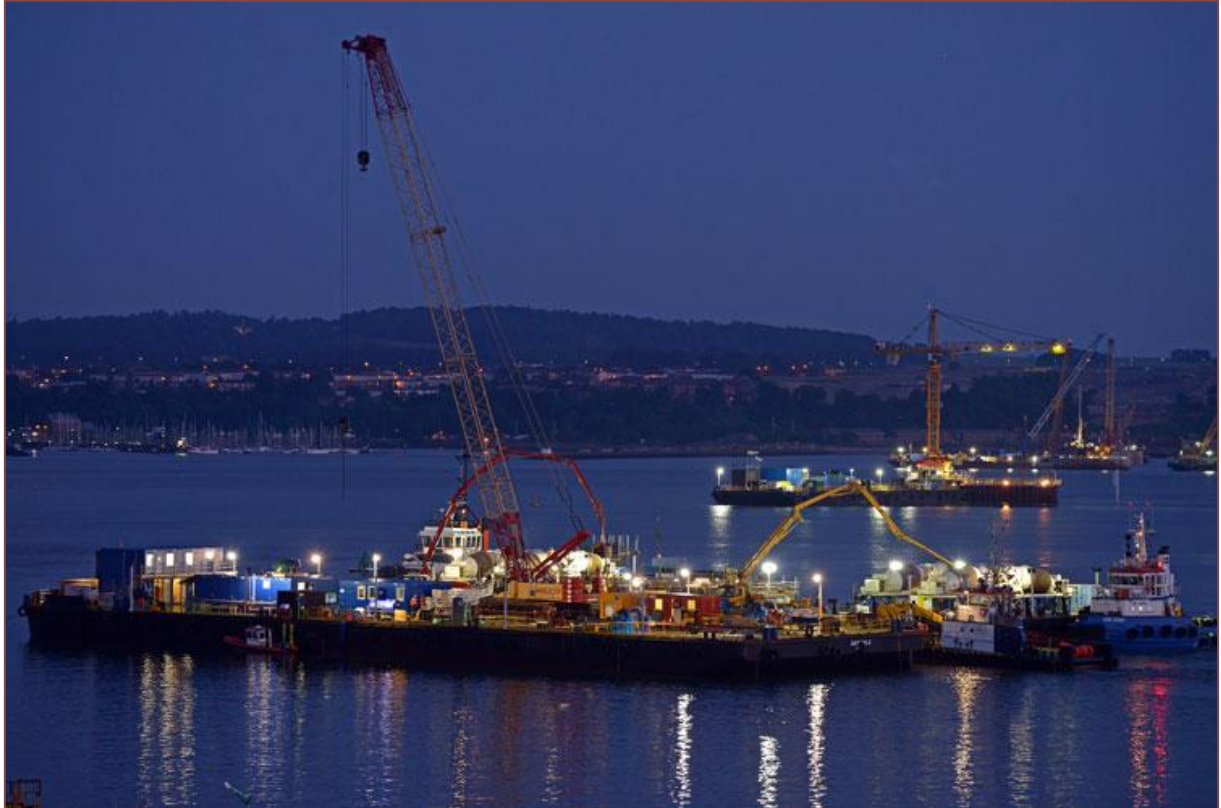
In September 2013, the world's largest continuous underwater concrete pour was achieved as foundation work progressed.

- In 2013 the world's largest continuous underwater concrete pour was achieved as foundation work for the huge 210 metre high Queensferry Crossing towers progressed.

- The huge 15 day, 24 hour non-stop operation successfully poured 16,869 m³ of concrete to the foundations of the south tower.

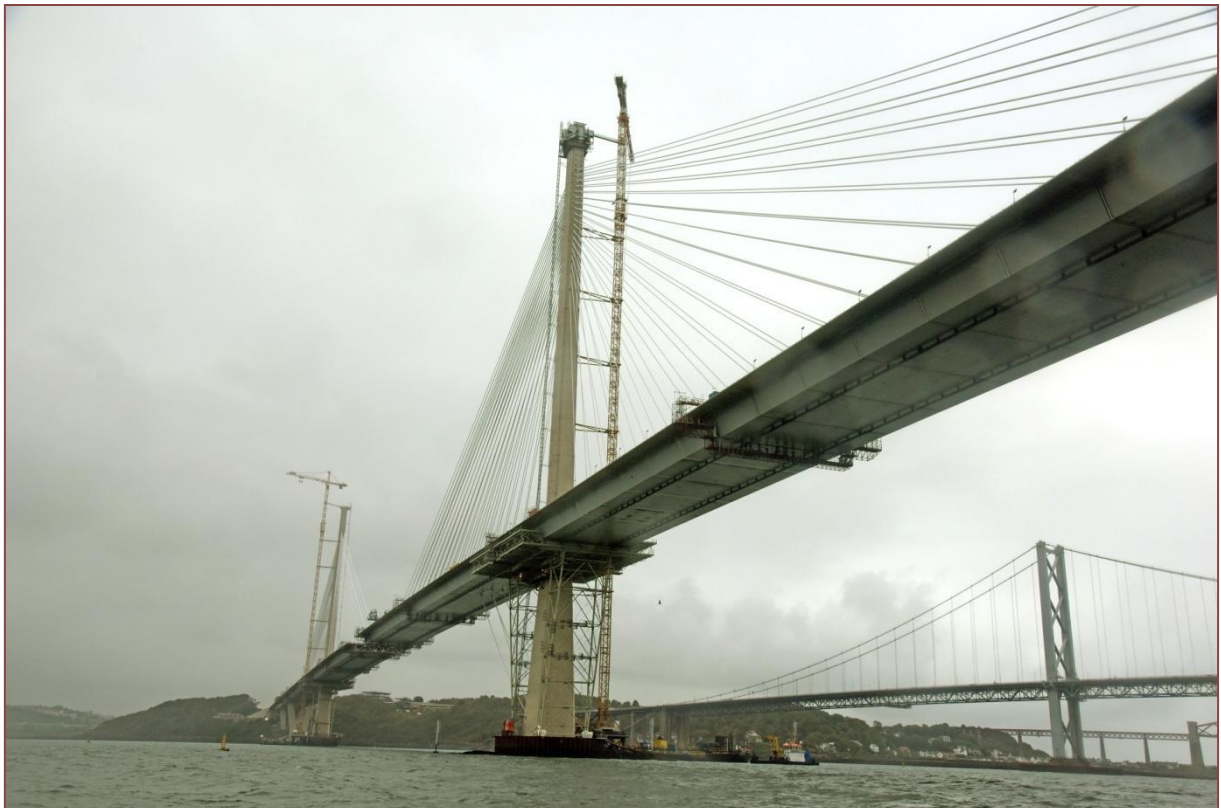
In October 2016 the central tower deck became the largest freestanding balanced cantilever in the world.

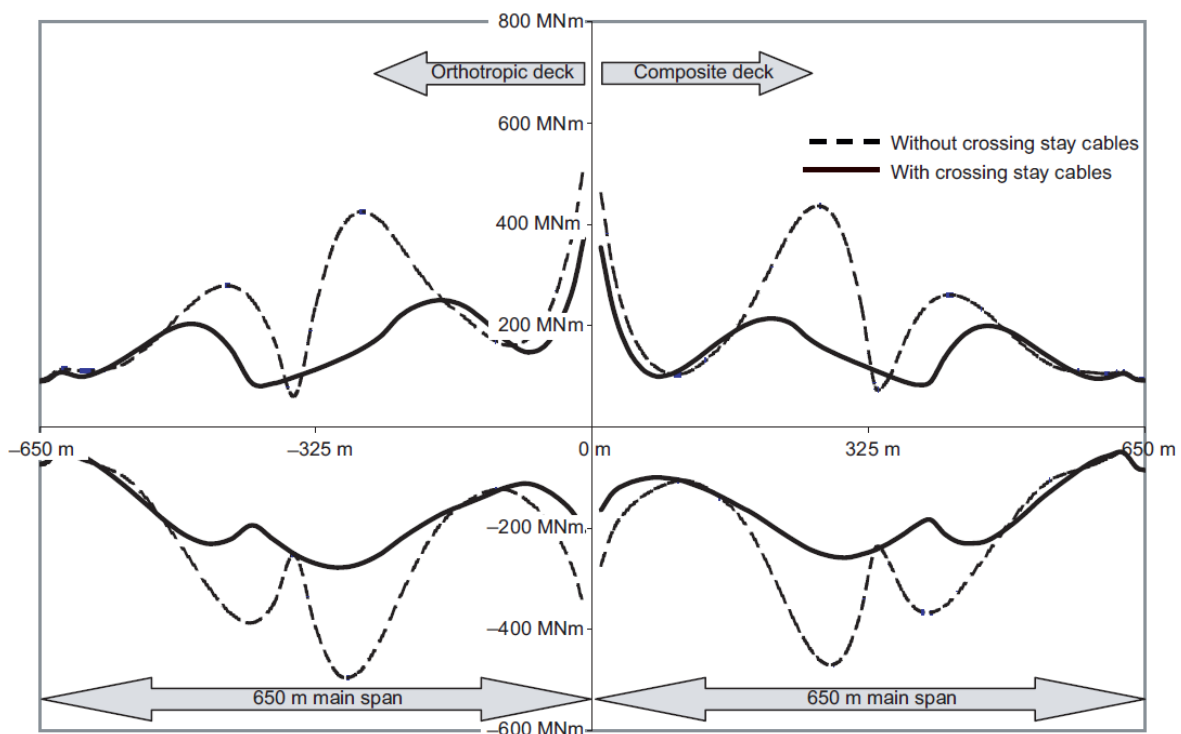
Figure 4: Crossing stay cable system: cable tensions due to out-of-balance loading

The deflections of the bridge were considered when only one of the main spans is loaded. The specimen design and an identical bridge without crossing stay cables were compared (load model 1 was applied in accordance with the UK national annex to Eurocode 1 (BSI, 2008)). The orthotropic deck variant is generally more flexible than the composite deck because the lighter construction means reduced stay cable quantities with a consequent reduction in global stiffness. For this variant, the deflections increased if crossing stay cables are not provided, this would cause concerns over serviceability performance.

Deflections alone do not demonstrate the need for crossing stay cables for the composite deck variant. However, their benefit is more clearly revealed when the bending moment in the deck is considered. Figure 4 shows the live load bending moment envelope for the case with and without crossing stay cables. Both main spans are shown with the central tower located at $x = 50$ m. Significant moments are developed in the deck when crossing stay cables are not provided. The virtual truss system is effective at reducing these moments, allowing savings in structural steel and preventing crack control difficulties in the concrete slab of the composite variant.

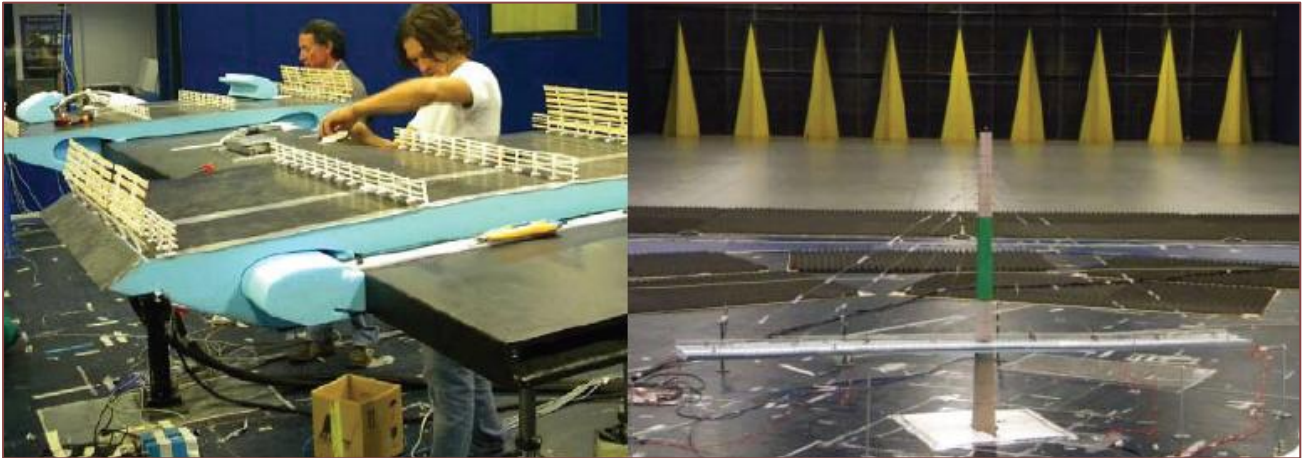
Figure 6: Wind Tunnel Testing: Deck section and balanced cantilever from Central Tower

Two stages of deck sectional model wind tunnel tests were carried out. Preliminary tests at 1:50 scale were carried out on a number of different sections at the BMT fluid mechanics tunnel (Teddington, UK) to investigate aerodynamic stability and force coefficients of several different bridge configurations under consideration. After selection of the preferred scheme, additional tests were carried out at 1:40 and 1:30 scales at the Politecnico di Milano (Italy) to investigate a number of different options for wind shields on the bridge deck; these tests confirmed the aerodynamic stability and force coefficients as well as establishing the shielding effects of the wind shields.

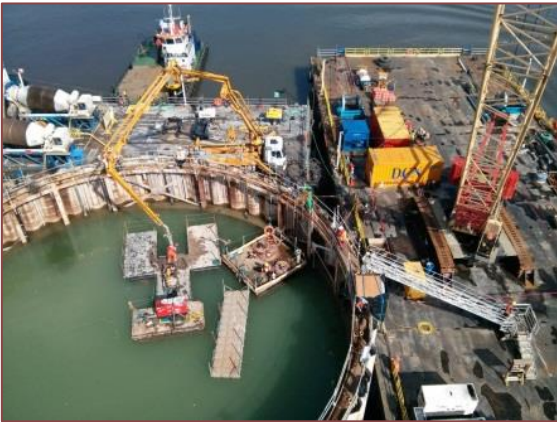
Figure 5: Pour Set- Up at Caisson

To achieve a plug seal, underwater concrete was required to be poured in a continuous process without interruption. 16,852 m³ of concrete was supplied at the South Tower (the largest continuous offshore supplied underwater concrete pour in the world), continuously supplied with an average rate of 60 m³/hr, to the deposition point over 2 miles away from the loading station at the quay wall.

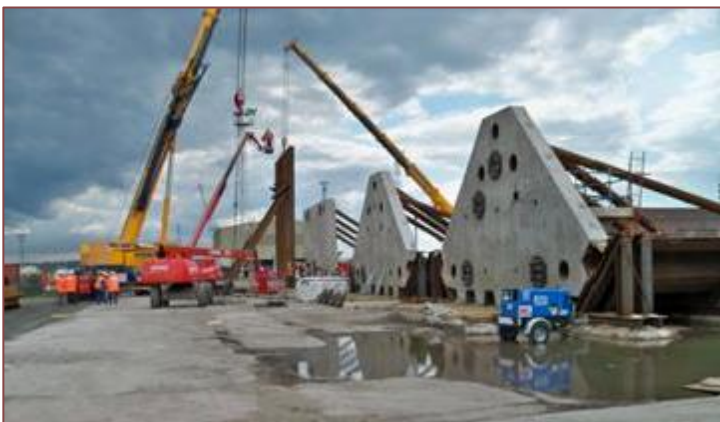
Figure 7: Cofferdam during construction

The cofferdam units were installed into the perimeter trench from the GPS Atlas floating crane with diver support. Each unit was placed and then the annulus between the unit and the formation filled with underwater concrete. With all the cofferdam units fixed into position, the gaps between each unit were filled and sealed. Large section props were then installed to ready the cofferdam to resist hydro static loads. Finally, de-stressing wells were installed in the rock formation to reduce up-lift pressures which might heave the formation on de-watering.

Once the cofferdam was fully constructed several large 150mm pumps were engaged and the water removed to expose the formation within the centre of the cofferdam.

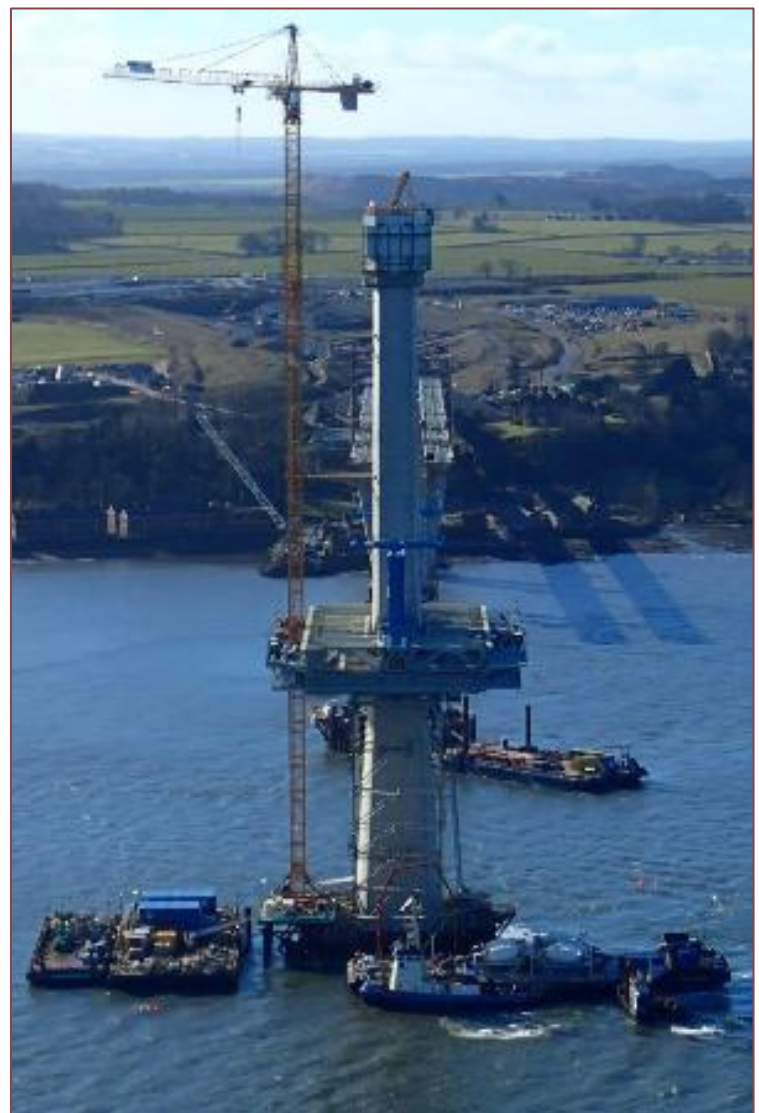
Figure 11: Concrete barge and distributor

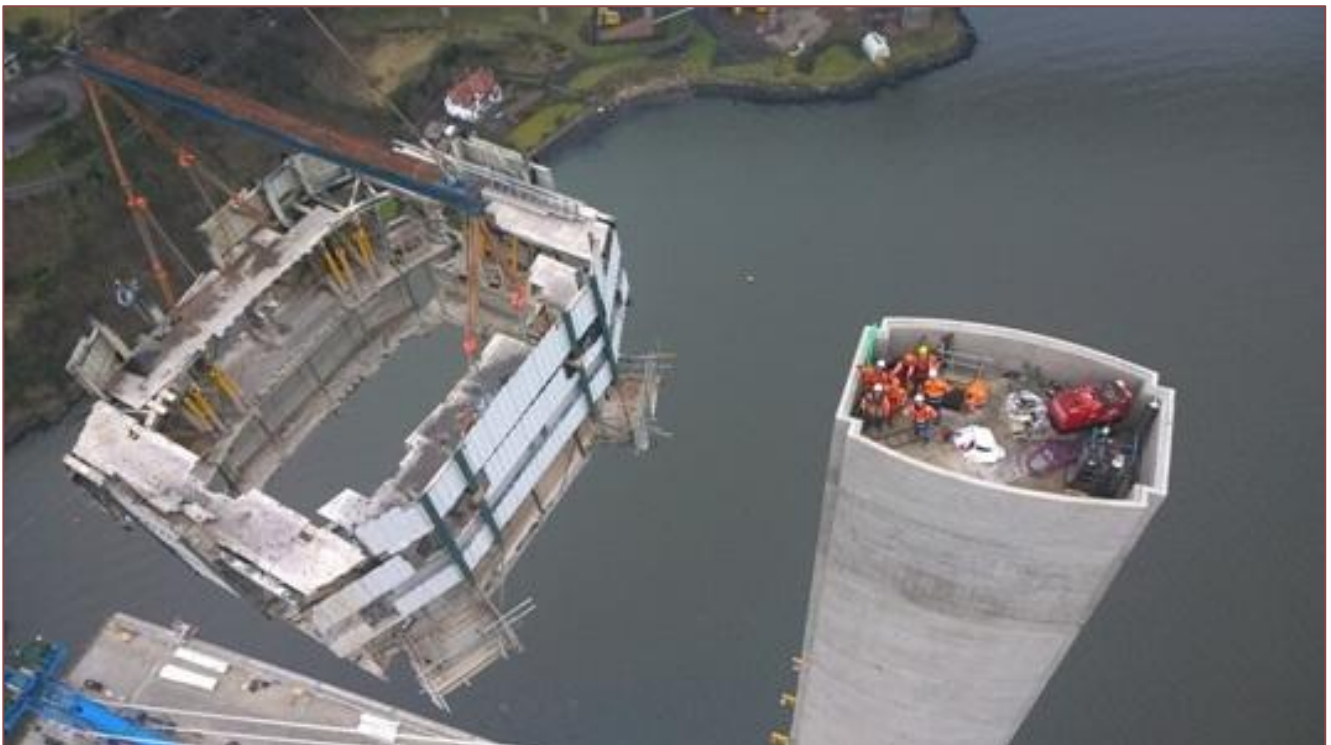
Figure 12: North tower – temporary formwork is lifted off

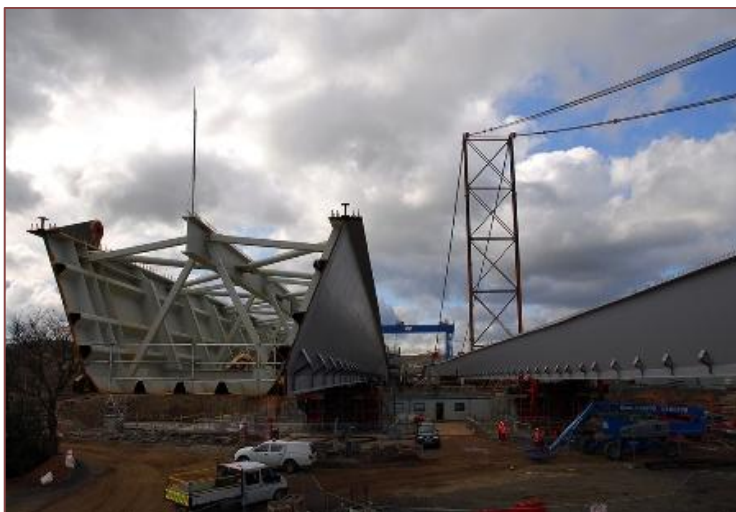
Figure 15: SAV box girder and king post

These spans comprise a 75m length of twin box in the first span, a transition segment, and 146m of single box complete with stay anchor webs, which connects to the cable stayed north fan.

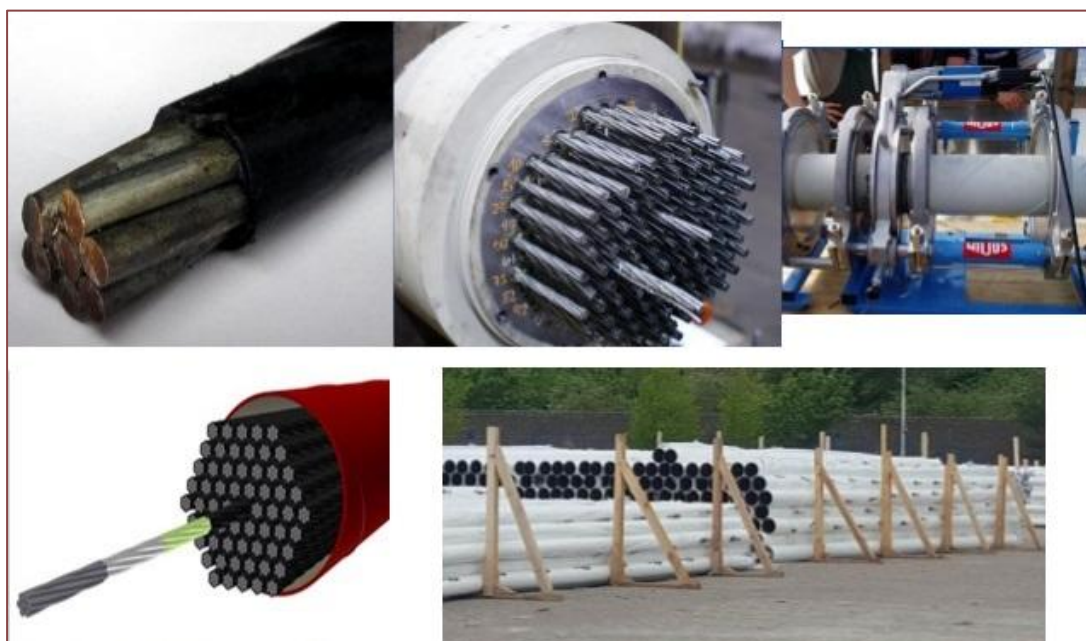
Figure 27: Cables

The future access to the deck is provided via underslung gantries from abutment to abutment. Internally there will be a shuttle running the entire length of the structure, 2633m, to transport personnel and small hand tools. Demountable cradles will provide external access to the towers and cables.

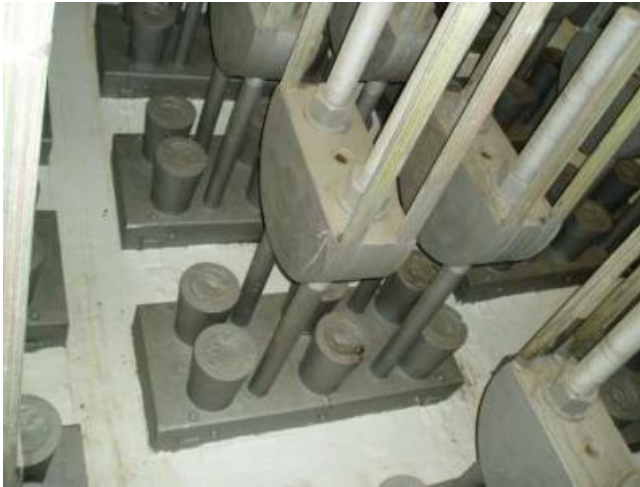
Figure 5: Cross Head Slabs

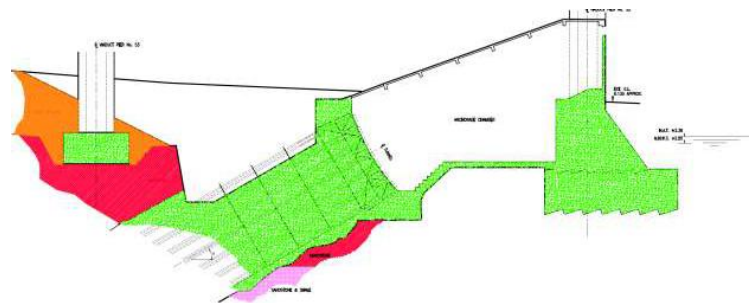
Figure 7: Excavation – overburden, rock and concrete

The main task was to excavate down behind the south west and south east anchorage chambers to expose the top of both the west and east tunnels. The concrete was removed by hydro-demolition. All 18 ducts were opened, grout washed out and wires inspected.

- Excavation behind the anchorage chambers down to the top of the tunnel to expose, inspect and test the pre-tensioning strands.
- The full scale load testing of a number of the sockets within the anchorage chamber (which was not accepted).
- Non-destructive testing – e. g. Acoustic monitoring, the use of radar, radiography and magnetostriction scanning.

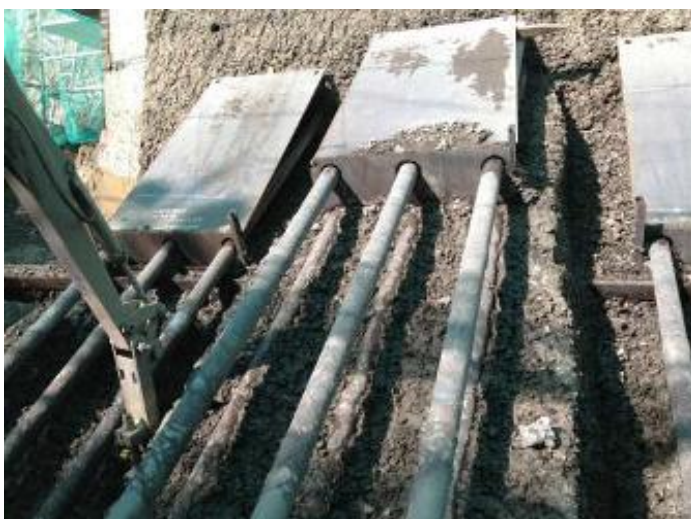
Figure 9: All ducts exposed in south west tunnel

The ducts and grout were reinstated followed by sequenced mass infill concrete casting.

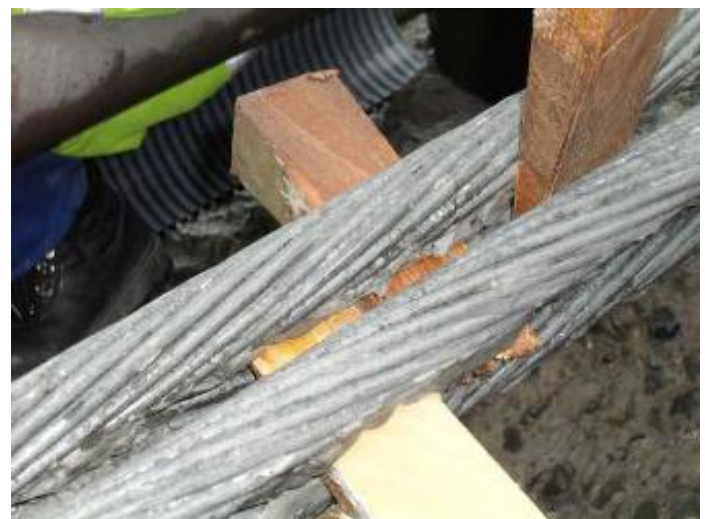
Figure 10: Strands exposed and wedged to enable visual inspection around the circumference

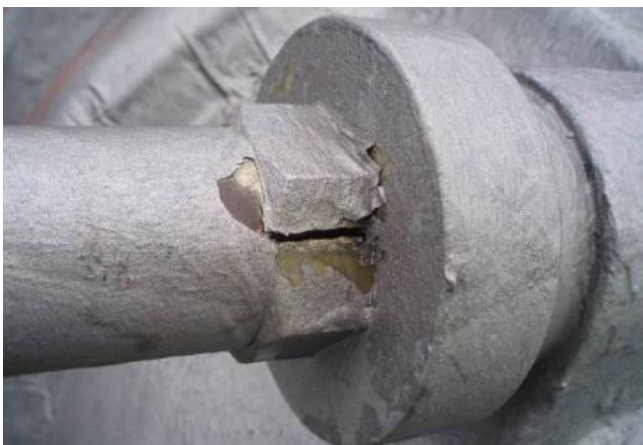
Figure 11: Example cracked nut as found

In March 2012 during inspection of the cable following completion of the dehumidification project a further 17 cracked nuts were found. It was decided to undertake the replacement of all 944 bolt assemblies on the bridge, in order to reinstate the structural integrity of the hanger system and minimise the risks to traffic.

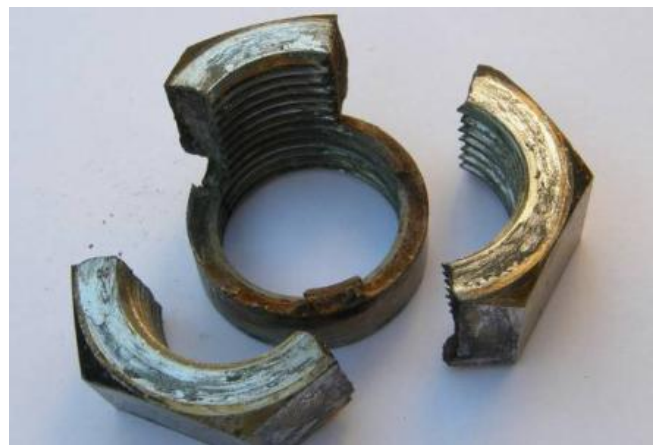
Figure 12: Example cracked nut after removal

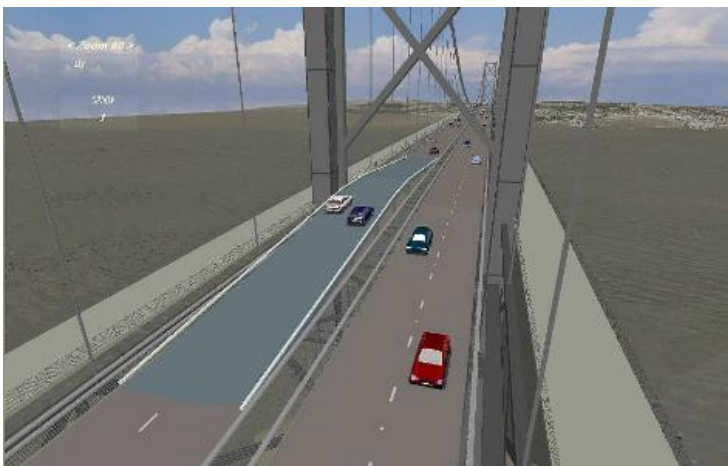
Figure 14: Virtual reality model of ramps

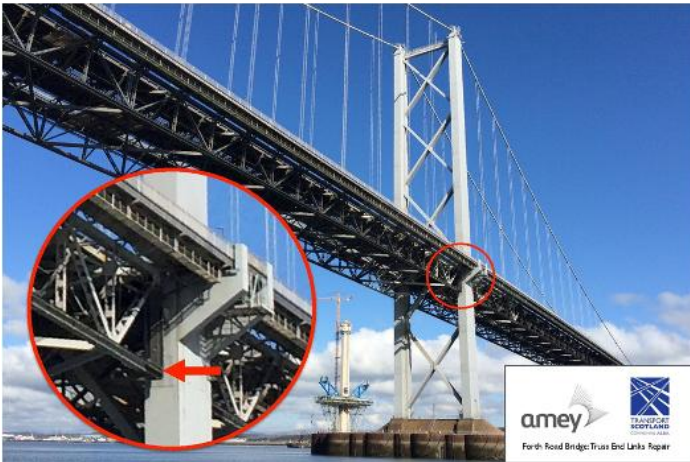
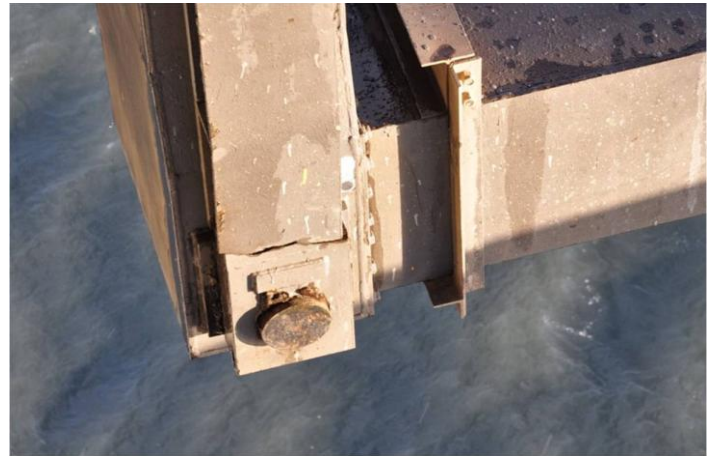
The photographs on this page show the location of the failed truss end link, on the south side of the north main tower and a close up of the failed member showing the crack.

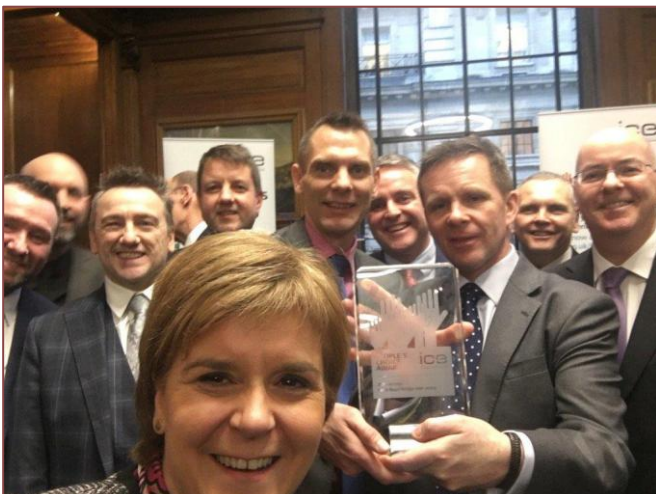
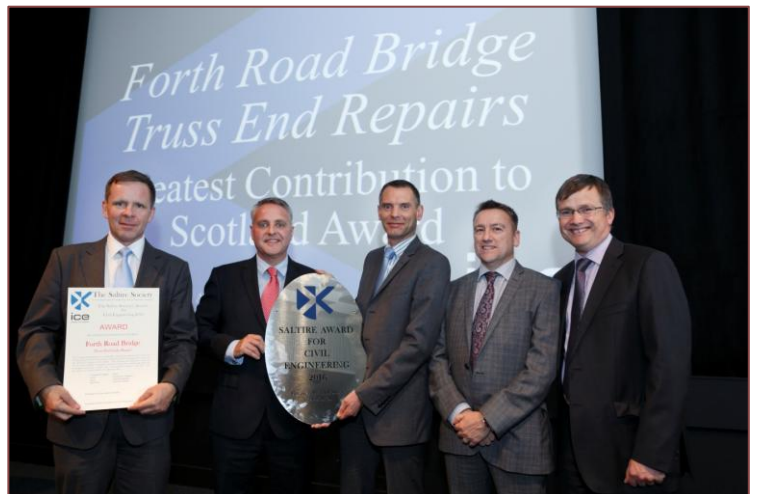
Forth Road Bridge reopening

The iconic Forth Road Bridge was closed to traffic in December 2015 following discovery of a fractured truss end link. Engineers reopened the repaired bridge within three weeks.

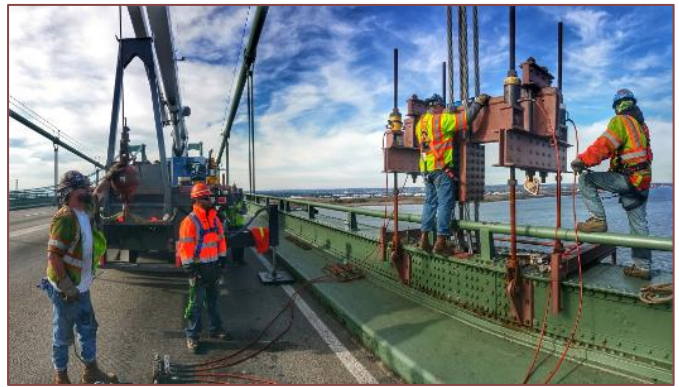
Suspender Replacement

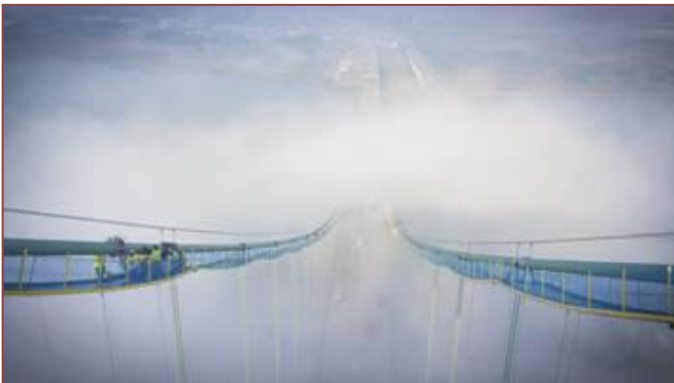
Delaware Memorial Bridge – Dehumidification of the main cables
