e-mosty

ISSUE 02 / JUNE 2017

SUSPENSION BRIDGES

THE DESIGN AND THE CONSTRUCTION

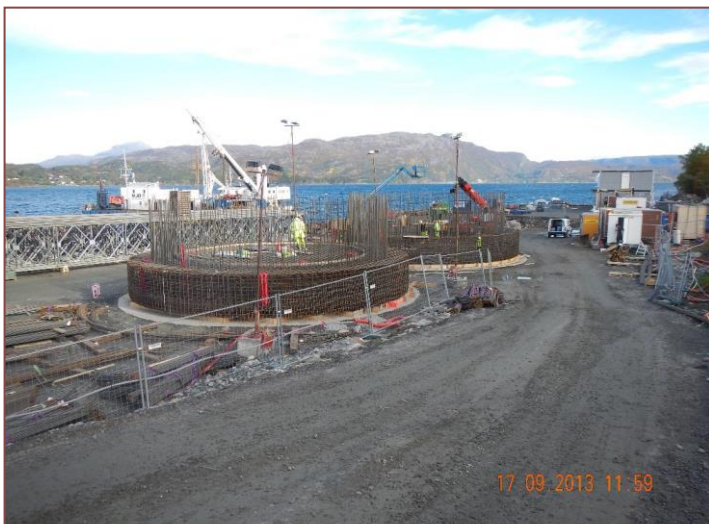
Figures 16 + 17: Caisson foundations

slip form casting. It was the first time that slip forming of caissons was permitted by the Norwegian Public Roads Administration. Slip forming is a construction method whereby concrete is cast in layers in a slip form that is raised at regular intervals. For production of the caissons a total of 3m of the foundation was cast and then lowered into the water every day.

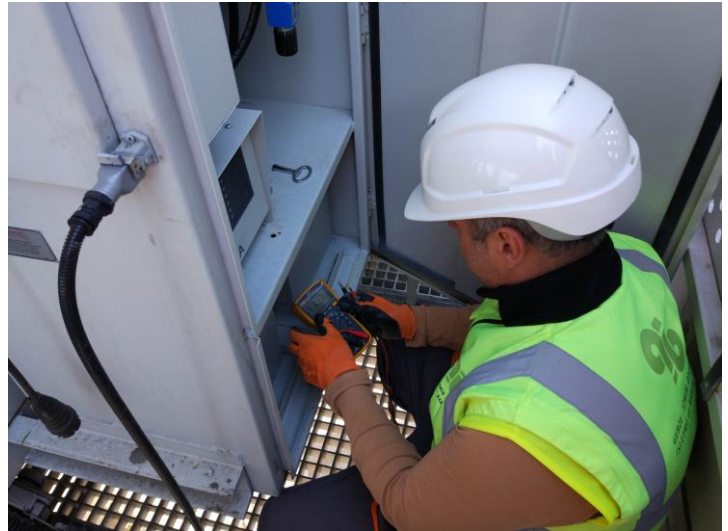
Figure 8: Routine inspection of accumulator of deck gantry man lift

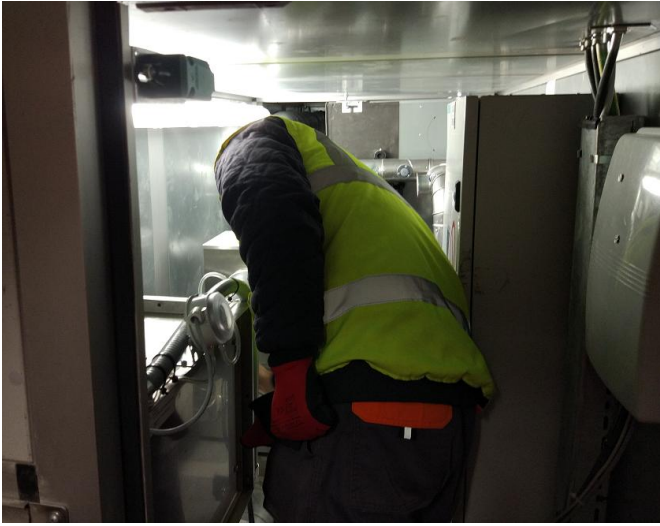
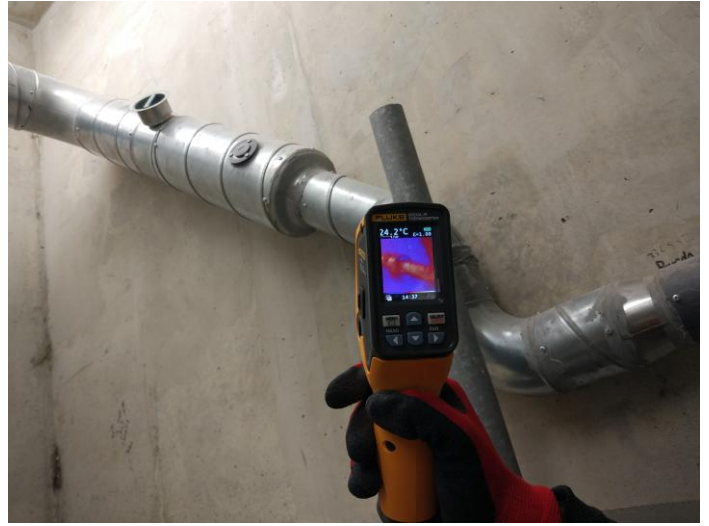
Figures 11 + 12: Routine inspection of dehumidification pipes at South Anchorage Block Back Chamber East

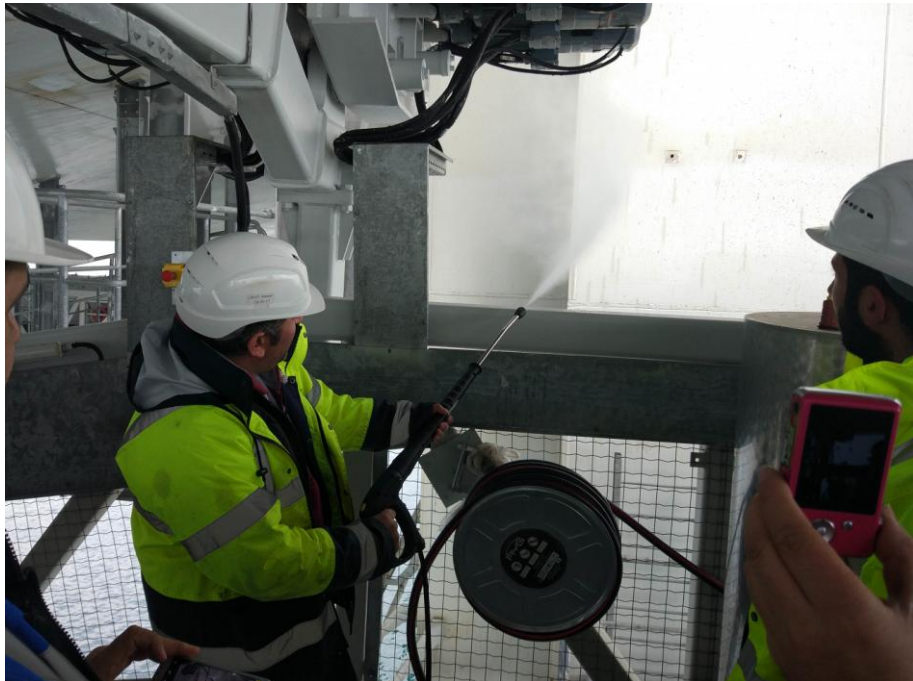
Figure 13 ↑: Routine inspection of water jet at deck gantry

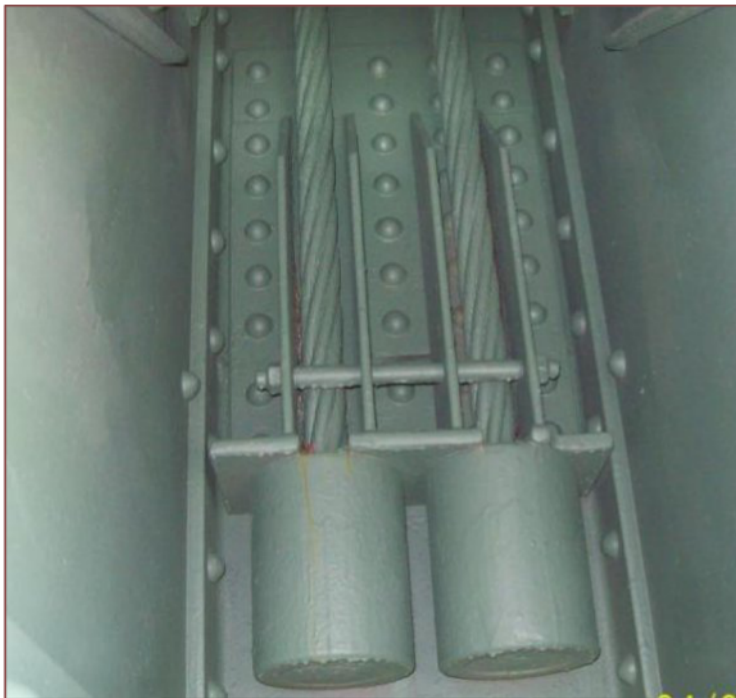
Figure 5: Typical suspender socket detail on a US suspension bridge

This movement can cause the most severe effect on the short hangers and the wires at the socket

interface are prone to fatigue damage at this point. In addition, experience has shown that no matter how diligently the suspenders are painted, because of their construction, water will find a way into the ropes, and collect at the socket. When dirt and road salts are added to this mix, the result can be accelerated corrosion, broken wires and a loss of strength. The typical end bearing socket detail is usually below deck level in a confined area as shown in Figure 5, which can cause water and dirt to be trapped and make inspection and maintenance difficult. Making sure these sockets are washed down regularly to remove dirt and salt is extremely important.

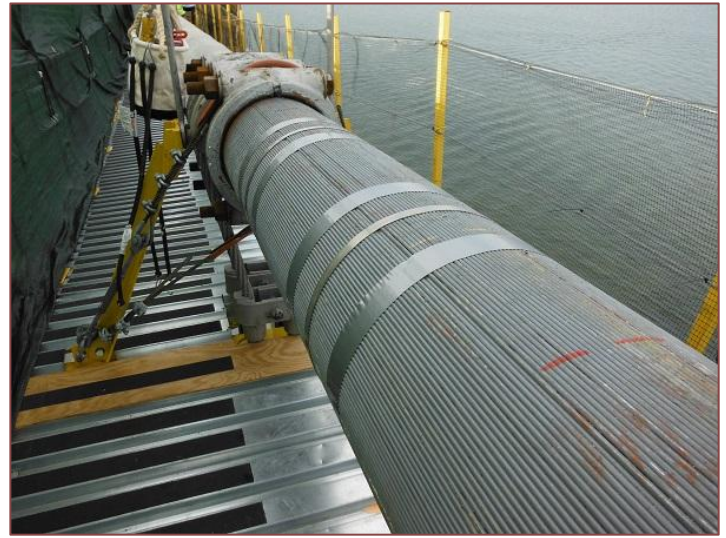
Figure 2: Helical strand cable, Eastbound Bridge (left); PPWS cable, Westbound Bridge (right)

Each of the cable types was rather unique for their era of construction and different than the system first notably used on wire cables by John A. Roebling for the Brooklyn Bridge in 1883. This system included galvanized wire, red lead paste, galvanized wrapping wire and paint, and became a generally adopted cable corrosion protection system used around the world.

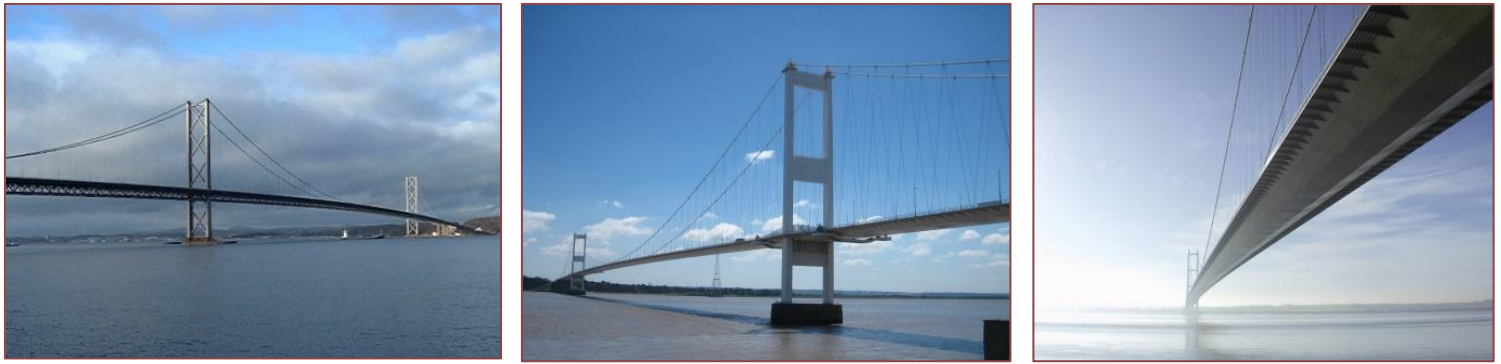
Figure 3: AECOM cable dehumidification projects in the UK – Forth Road ←, M48 Severn ↑, Humber →

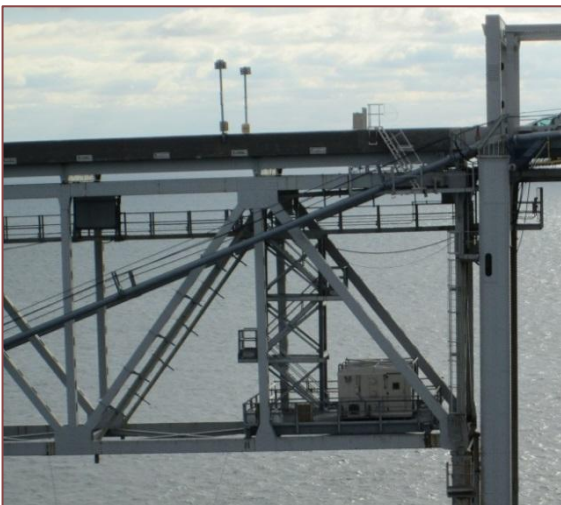
Figure 7: Eastbound plant room on platform; backstay and approach span on left, suspension span on right

Potentially suitable plant room locations were limited on the Eastbound Bridge, since the cable anchorages were at water level. Having only 2-lanes, the Eastbound Bridge was also less accessible from lane closures in comparison to the Westbound Bridge. Therefore, a single plant room at the east end of the bridge under the approach span was considered to be most practical to facilitate future maintenance and reduce capital cost (Figure 7).

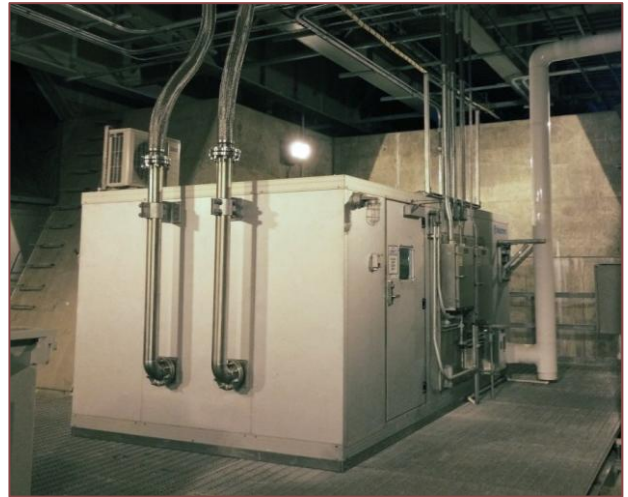
Figure 8: One of two plant rooms on Westbound Bridge within anchorages

Plant rooms on the Westbound Bridge were conveniently located inside each of the anchorages at deck level. This had several advantages including no traffic vibration, good maintenance access, shelter from the elements, more stable temperature conditions and lower cost lightweight plant room framing and wall components (Figure 8).

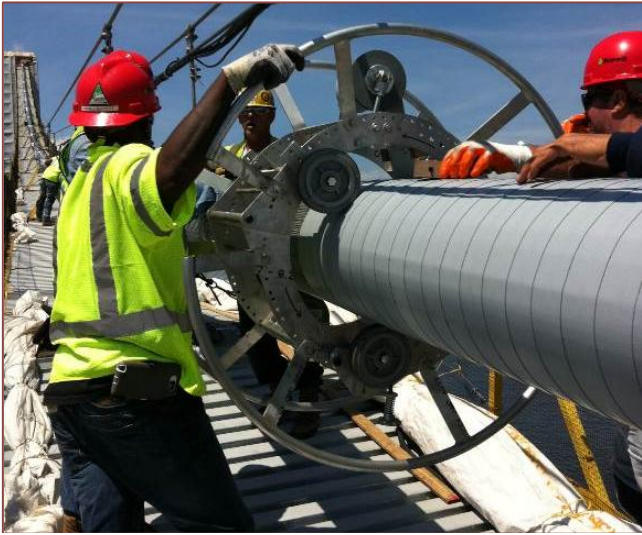
Figure 9: Cable wrap being spirally wound using a wrapping device (Skewmaster™)

The new cable wrapping was applied spirally over the bridge cable under tension using a Skewmaster™ wrapping device (Figure 9). The wrapping was performed uphill to create an overlapping shingle-effect so as to avoid water ingress from surface water running down the cable.

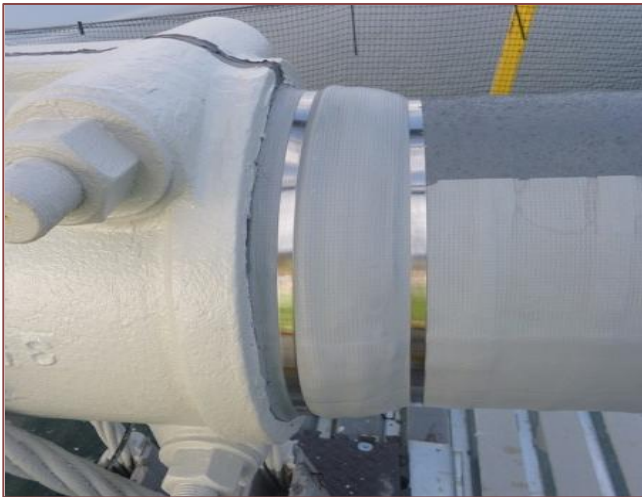
Figure 13: Finishing strip at cable band interface

Once both were placed, a finishing strip of cable wrapping was installed and then completed with the installation of two additional stainless steel strap bands. The finishing strips provide a neat and durable detail and protect the underlying sealing materials from the environmental elements (Figure 13).

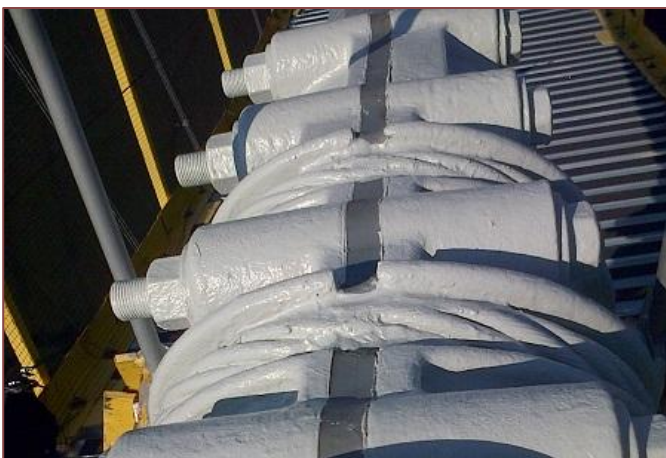
Figure 14 ←: Westbound Bridge cable band longitudinal gap with new caulk sealant

For the Westbound Bridge the cable band gaps were approximately 19mm wide. The existing caulk sealant was removed and replaced with modern sealants, providing both a weather resistant and airtight seal (Figure 14).

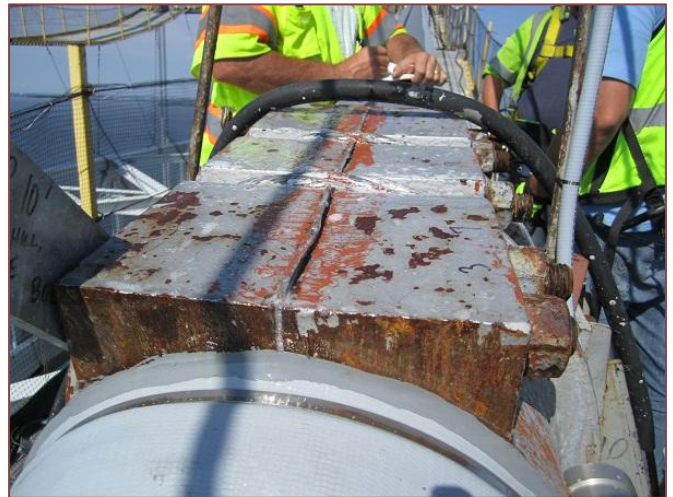
Figure 15: Eastbound cable band gap filled with lead sealant

However, for the Eastbound Bridge, the cable band gaps were much narrower and ranged from 2mm to 6mm. The gaps were originally filled with a lead seal that proved difficult to remove due to the hardness of the sealant and the narrow width of the gap (Figure 15). While removal of the existing lead would allow the placement of modern sealants, it was believed that the removal process would have been overly intrusive and not beneficial to the overall sealing of the cable band.

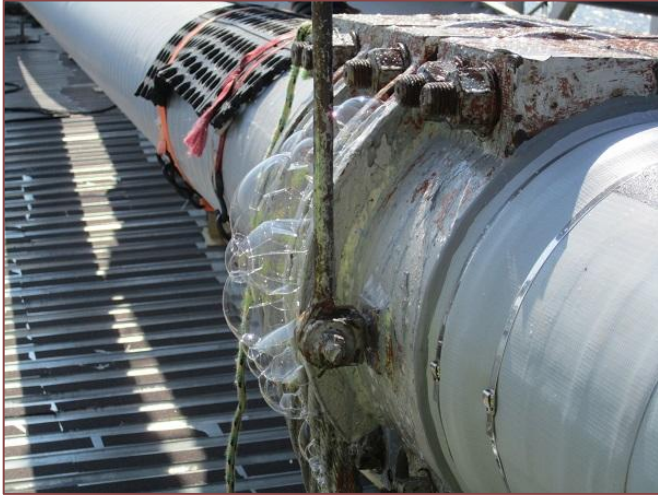
Figure 16: Air trials with soapy water test on in-situ cable band
(note bubbles detecting leaks around cable band bolts and suspender ropes)

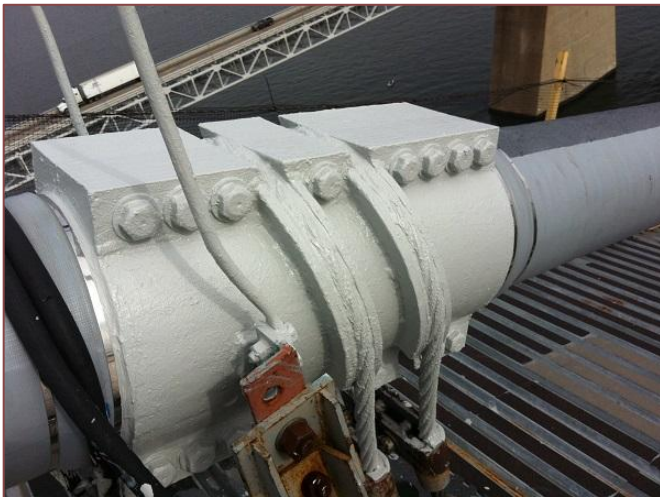
Figure 17: Eastbound cable band with new elastomeric acrylic coating system

Following the initial tests, suspender ropes were caulked within the cable band guides, and the cable band bolts were cleaned and coated with an elastomeric acrylic coating system for a subsequent air trail. These details were proven to be sufficiently airtight for the purposes of dehumidification and were therefore implemented on the remaining cable bands (Figure 17).

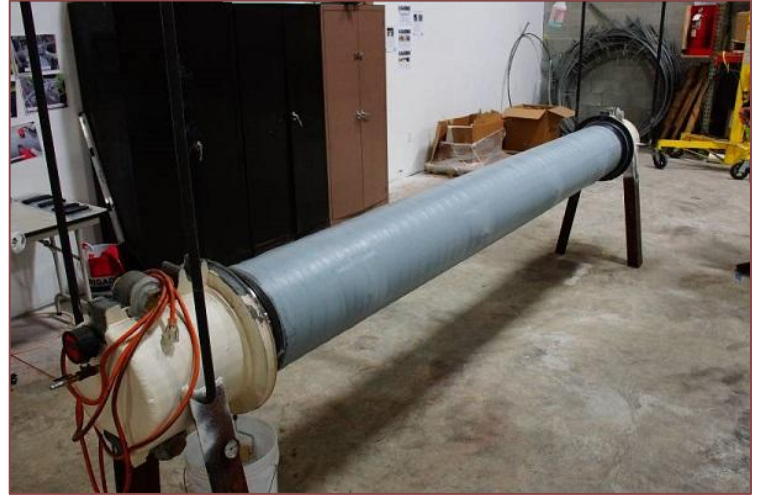
Figure 18: Shop test rig

The successful completion of the main cable wrapping and sealing began with contractually required shop trials. The contractor was required to demonstrate the ability to provide an airtight wrap, including the cable band seals, prior to applying the wrap and cable band sealing details on the bridge (Figure 18).

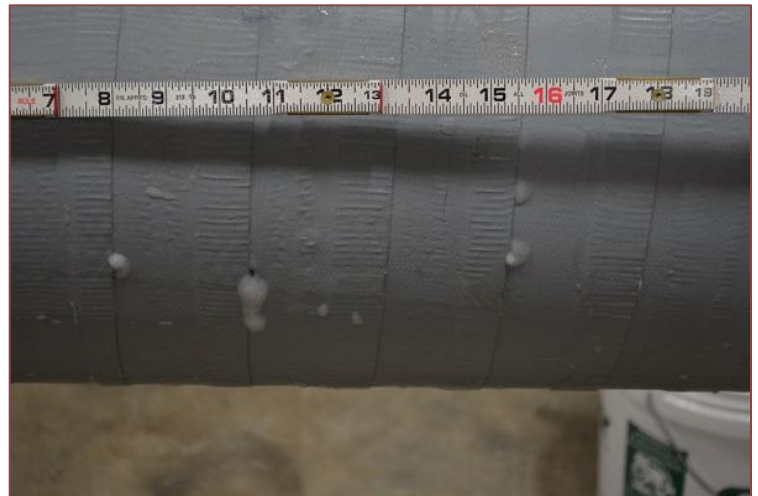
Figure 19. Soapy water inspection of cable wrap on shop test rig
(note the bubbles indicating air leaks in the overlap areas)

The test rig was required to be constructed to allow pressure testing and detection of leaks along the wrap and interface with the cable bands through soapy water inspection (Figure 19).

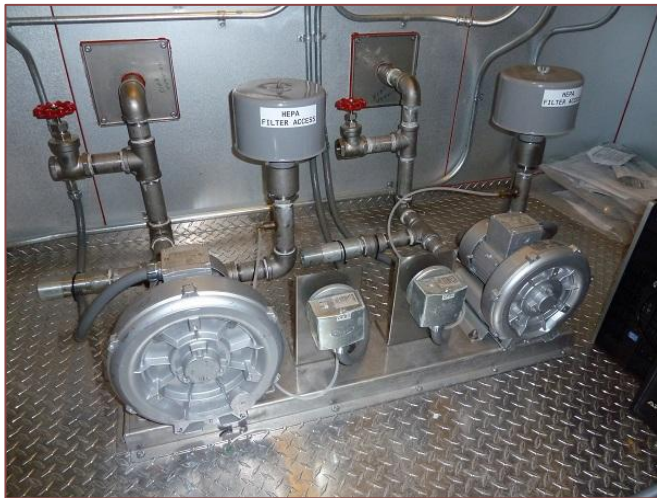
Figure 20: Injection fans with HEPA filters

The plant rooms house the mechanical systems for the development of a volume of stored dry air to be injected into the cables. Each plant room was required to be equipped with a desiccant wheel dehumidifier, plate heat exchanger and supply fans. The plant rooms were designed to function as insulated plenum chambers for the dehumidified air. This strategy allowed energy efficiency through passive heat recovery, close control of temperature and humidity and insulation against heat loss/heat gain. Standard off-the-shelf equipment was used to simplify future maintenance and reduce capital and long-term operational costs (Figure 20).

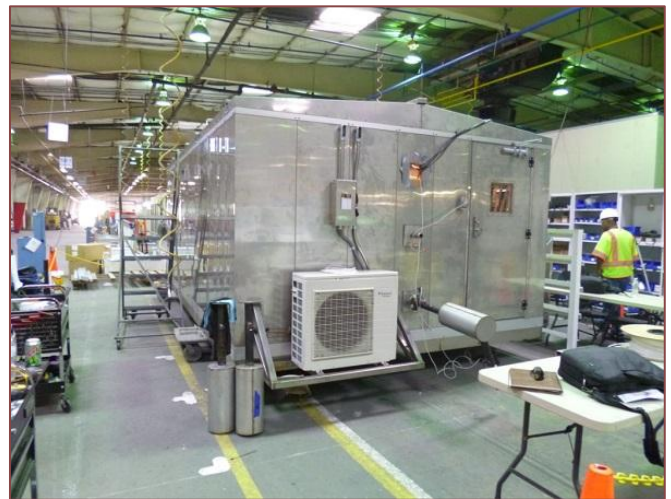
Figure 21: Eastbound Bridge plant room preassembly and shop commissioning

To facilitate system commissioning, the contract required the plant rooms and control systems to be preassembled in the shop and tested prior to delivery to the project (Figure 21).

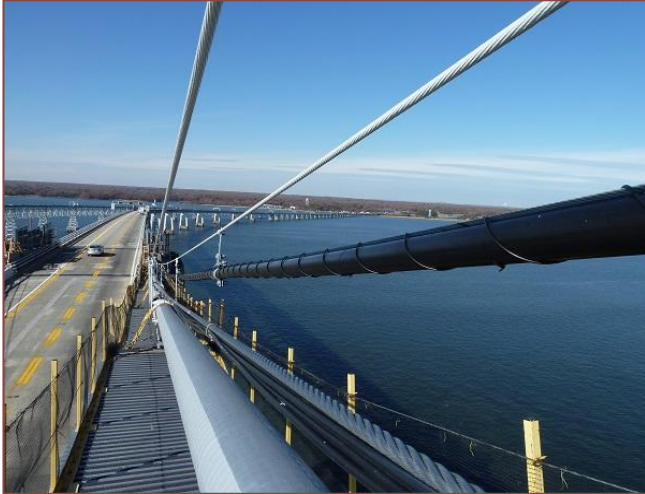
Figure 22. HDPE dry air supply pipework

The dry air developed in the plant rooms was required to be delivered to the cable by High-Density Polyethylene (HDPE) piping. The pipework was routed to the injection sleeves on the cable by messenger strands connected to the hand rope stanchions on the cable. The HDPE pipework was spirally lashed to the messenger strands for near-continuous support (Figure 22).

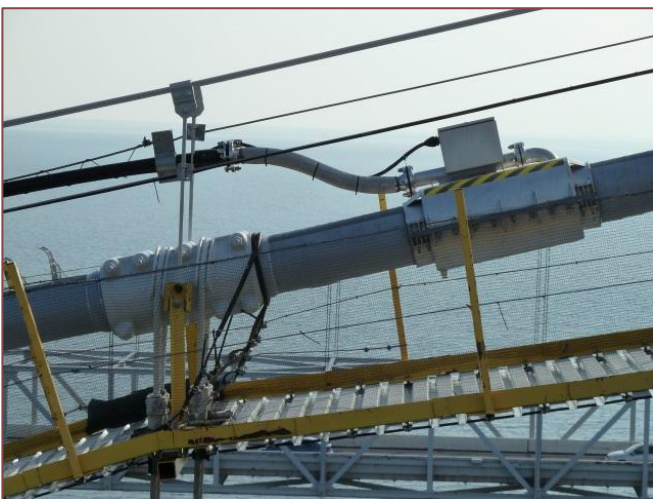
Figure 23. Flexible stainless steel pipe transition to injection sleeve

The rigid HDPE pipework was transitioned to flexible stainless steel braided pipes where relative movement needed to be accommodated, such as at the injection sleeves on the cables (Figure 23).

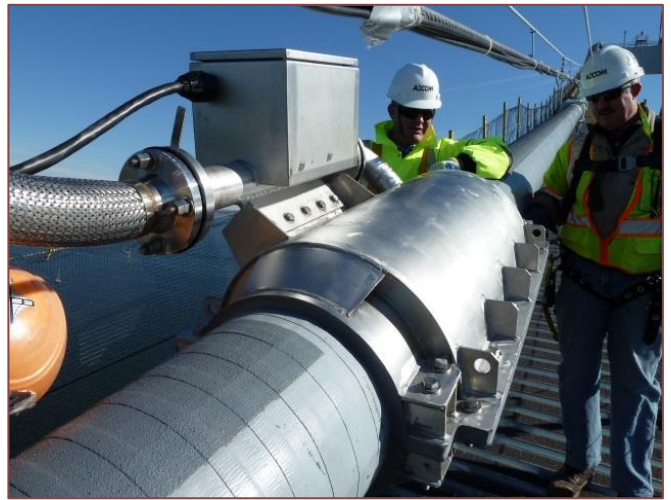
Figure 24. Cable injection sleeve (note sensor box on top)

The injection and exhaust sleeves are horizontally split stainless steel assemblies that accommodate either the injection pipe or exhaust port and integrate a network sensor box for data collection and monitoring purposes (Figure 24).

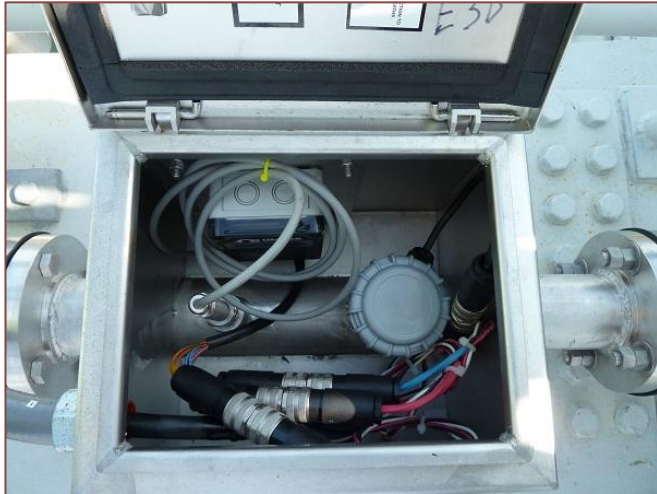
Figure 25: Sensors in NEMA 4X sensor box

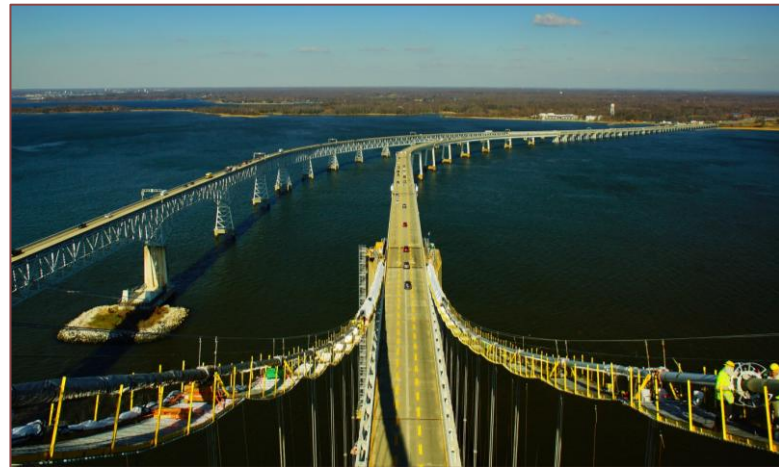
Figure 27: Main cable access platform; Westbound Bridge shown, Eastbound Similar
(Photo Credit: Christian Christodoulou, AECOM)
